Manhole Inspection Summary

Manhole # S1100_019MH

Location Address: **3035 PIEDMONT AVE**

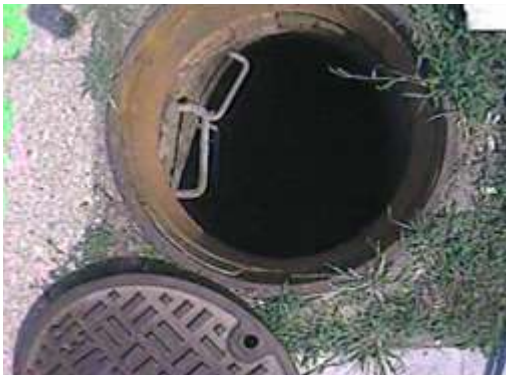
Top View

Frame Offset: **2** (in.) Condition: ☒ Sound ☐ Cracked ☐ Leaks

FRAME OFFSET.

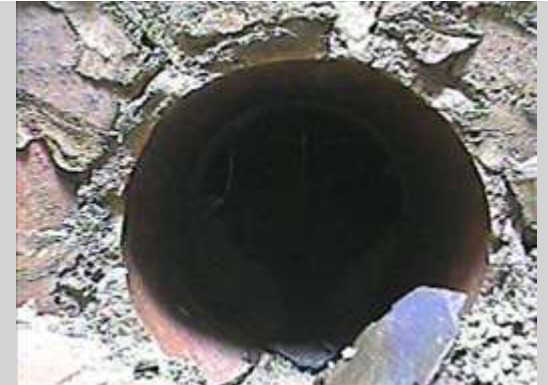
12 O'Clock Outflow

8 in. Circular Gravity Sewer
Pipe Out @ 12 O'Clock

Infiltration: **None** Pipe Seal Cond: **Broken**
